# 4-Point Inspection Form

Address Inspected: 123 Old Fashioned Tree Rd, Forestview 0567

Date Inspected: 07/12/2025

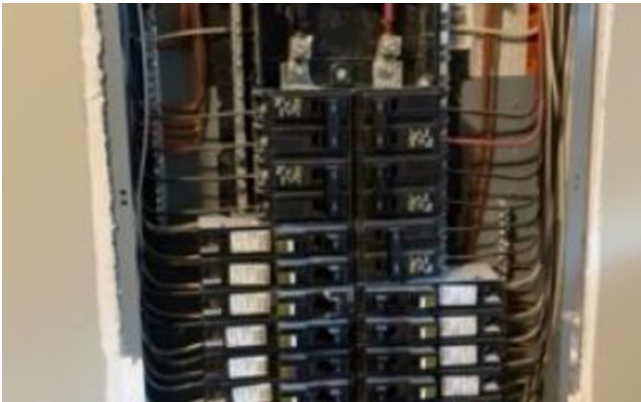
Main electrical service panel with cover removed

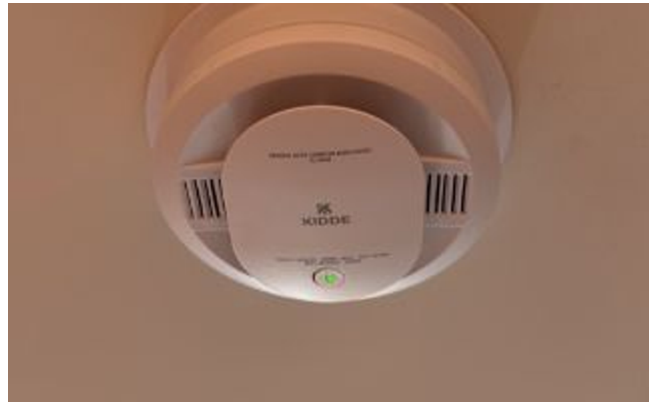
Smoke & Carbon Monoxide Alarm

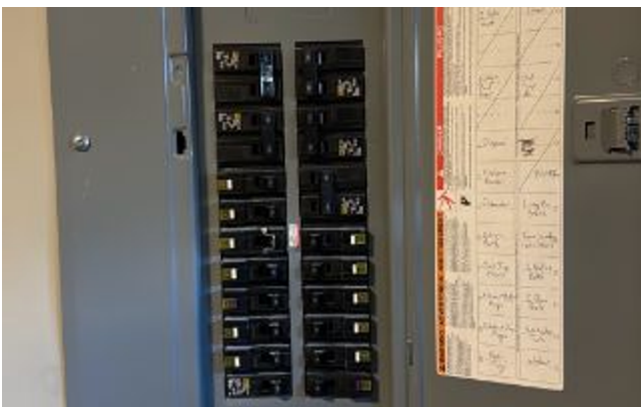
Main electrical service panel open

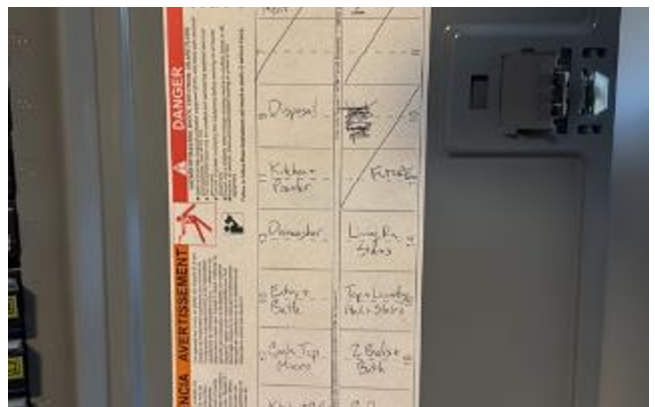
Main electrical service directory

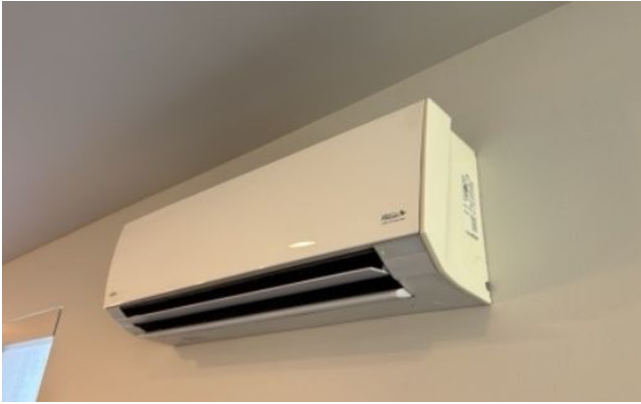
Indoor mini-split head unit

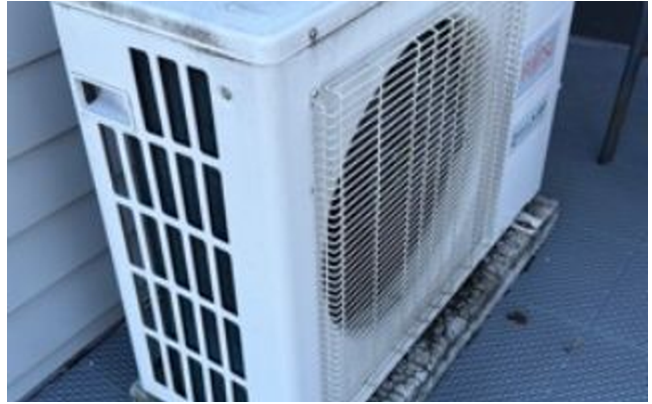
Outdoor Fujitsu condenser mounted on elevated pad

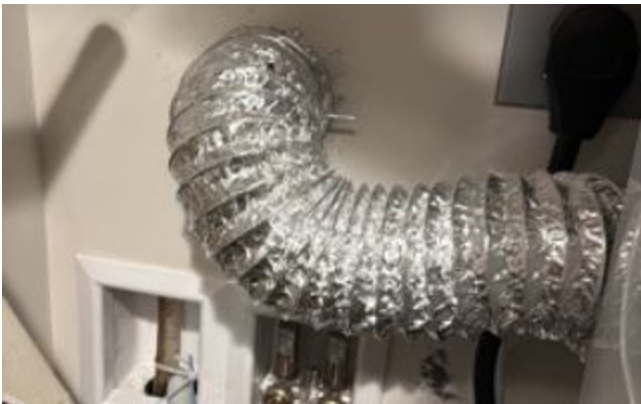
Laundry area vent duct and water connections.

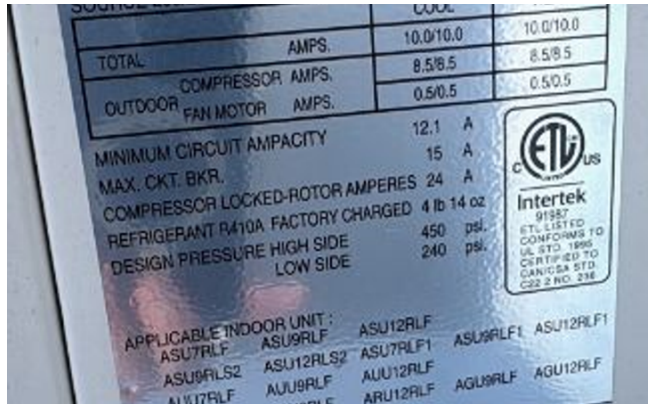
Manufacturer data plate for outdoor unit

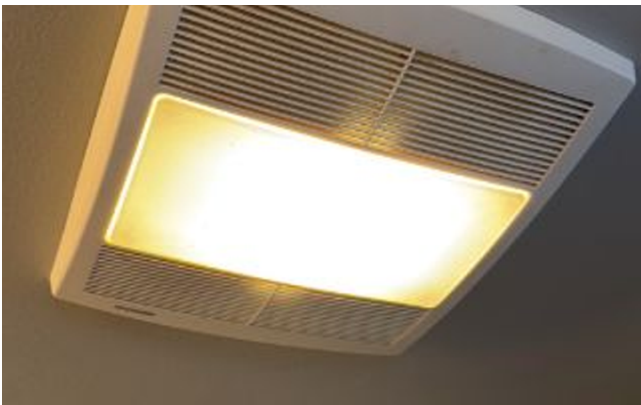
Bathroom exhaust fan

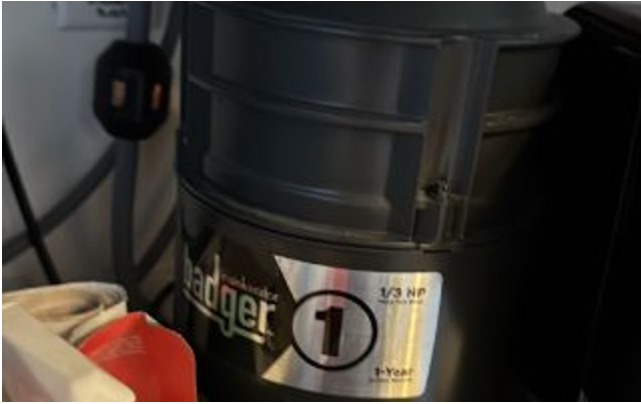
Under-sink garbage disposal (Badger 1/3 HP)

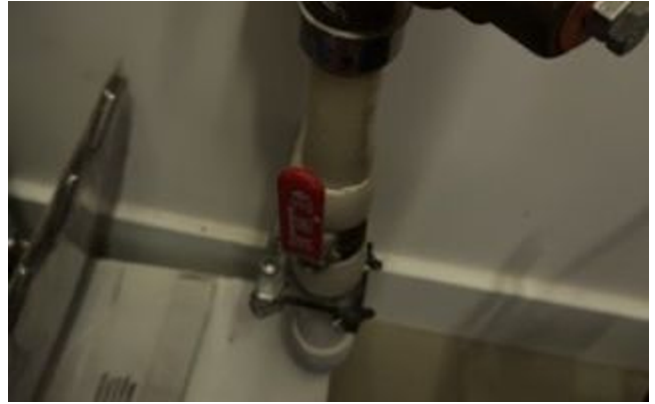
Cold water shutoff valve for water heater

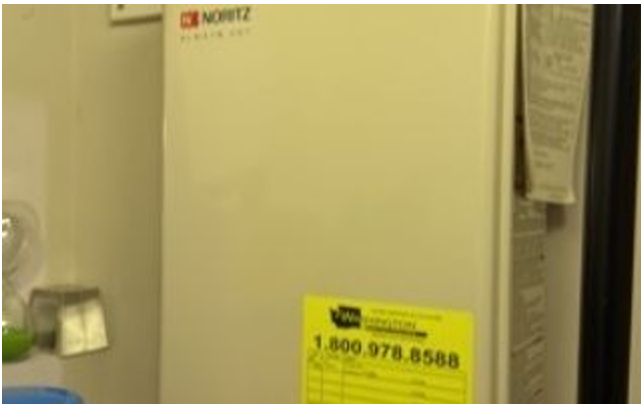
Water heater front view

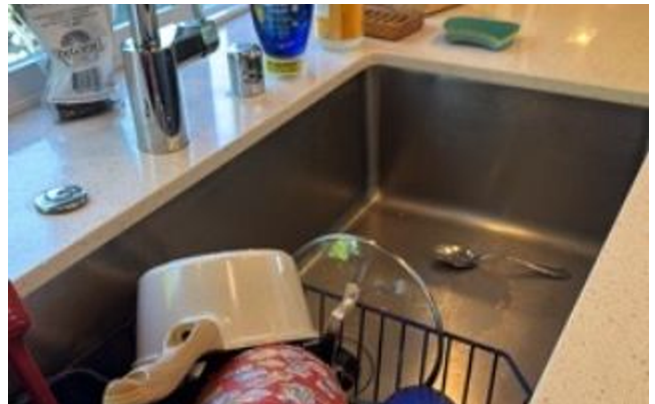
Kitchen sink and faucet

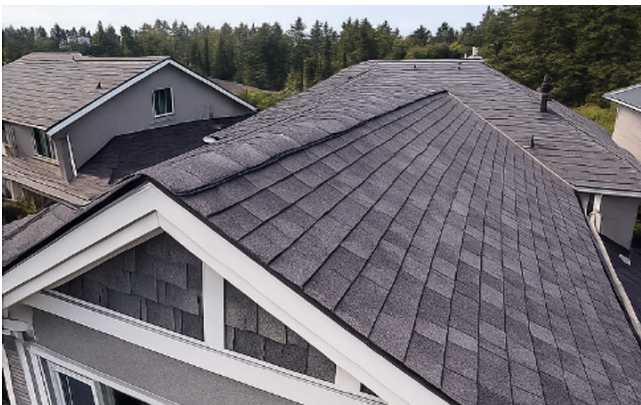
The four major systems of the home were evaluated based on visibly accessible components only. Overall, the dwelling appears to be in serviceable condition with typical age-related wear noted throughout. The roof shows minor granule loss and slight curling on sun-exposed areas but no evidence of active leaks. The electrical system is functional with copper wiring; one double-tapped neutral and an improperly sized breaker were observed and should be corrected by a qualified electrician. The HVAC system operated normally in both heating and cooling modes, though rust staining in the air handler drain pan and a slow-draining condensate line were noted. Plumbing fixtures tested satisfactorily with no active leaks; light corrosion at the water heater connections and a prior dry leak under a sink were observed. These items are common for a home of this age and do not appear to present immediate hazards.

Main upper roof slope and valley intersection

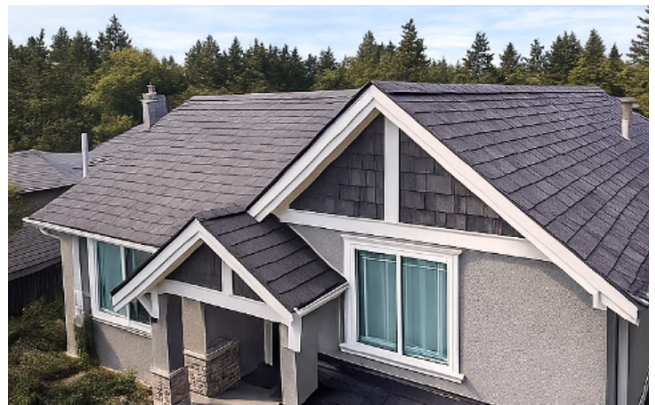
Left front roof slope and entry overhang

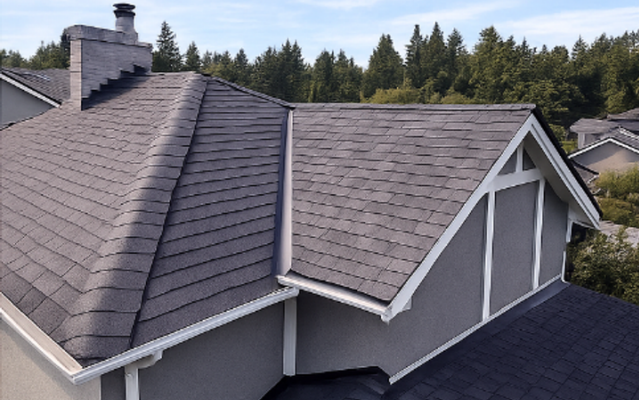
Rear roof slopes, ridge line, and intersecting gables

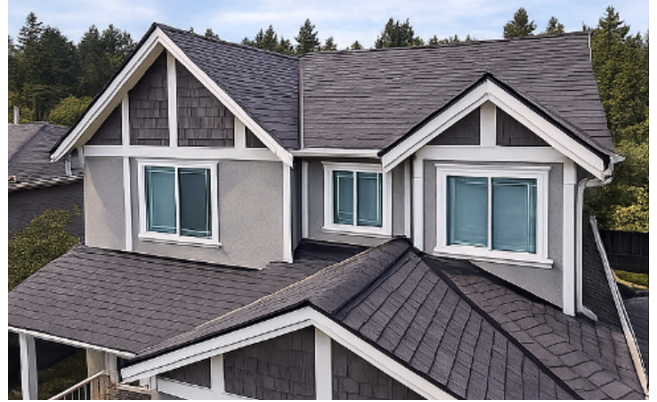
Front-facing roof slopes and gables

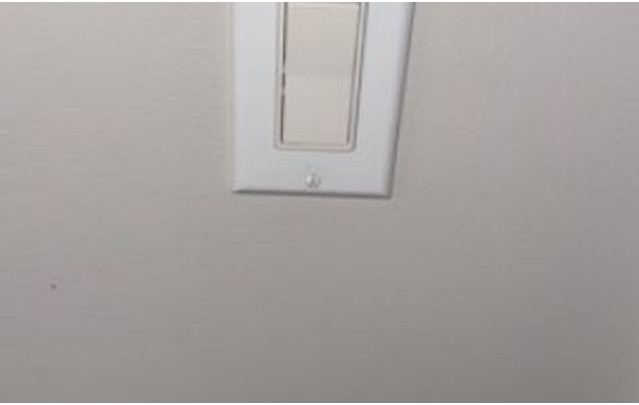
Loose switch plate
