## Uniform Mitigation Verification Inspection Form

Inspection Date: 04/08/2026		
Owner Information:		
Owner Name: Susan and Andrew Underwood		Contact Person: Andrew Underwood
Address: 148 Turtle Ave.		Home Phone: (555) 867-5309
City: Sarasota	Zip: 34237	Work Phone: (555) 222-5555
County: Sarasota		Cell Phone: (555) 867-5309
Insurance Company: Acme Insurance		Policy #: HP-123456
Year of Home: 1973	# of Stories: 2	Email: suzyq@treemail.com

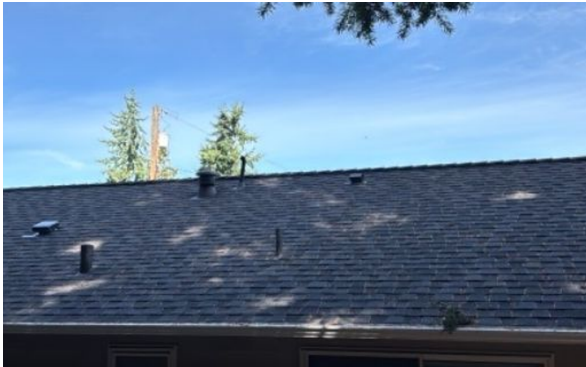
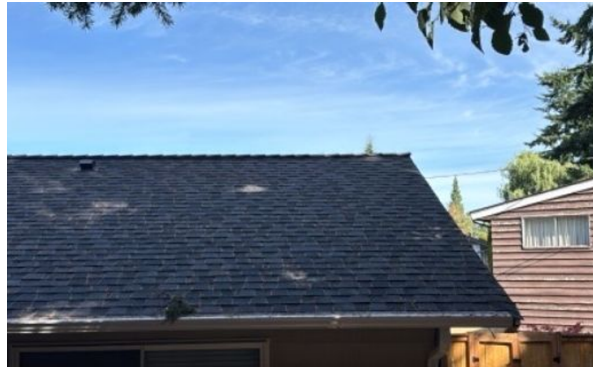
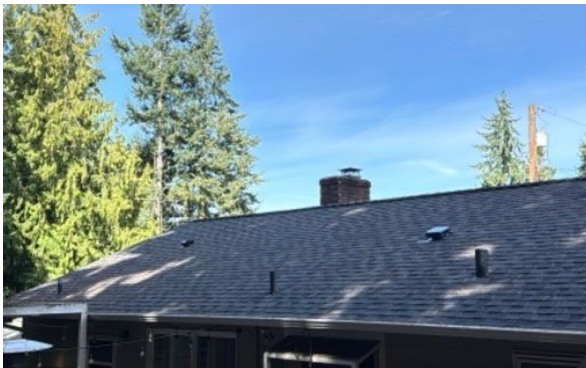
### 4. Roof Covering

4.1 Roof Covering Type:	Permit Application Date	FBC or MDC Product Approval #	Year of Original Installation or Replacement	No Information Provided for Compliance
<input checked="" type="checkbox"/> Asphalt/Fiberglass Shingle	<u>08/10/2016</u>	<u>FBC13567</u>	<u>2016</u>	<input type="checkbox"/>
<input type="checkbox"/> Concrete/Clay Tile	_____	_____	_____	<input type="checkbox"/>
<input type="checkbox"/> Synthetic/Composite Tile	_____	_____	_____	<input type="checkbox"/>
<input type="checkbox"/> Metal	_____	_____	_____	<input type="checkbox"/>
<input type="checkbox"/> Built Up	_____	_____	_____	<input type="checkbox"/>
<input type="checkbox"/> Membrane	_____	_____	_____	<input type="checkbox"/>
<input type="checkbox"/> Other _____	_____	_____	_____	<input type="checkbox"/>
